INDOOR AIR QUALITY ASSESSMENT

**Plymouth Department of Public Works
Annex Building
169 Camelot Drive
Plymouth, Massachusetts**

Prepared by:
Massachusetts Department of Public Health
Bureau of Environmental Health
Indoor Air Quality Program
May 2017

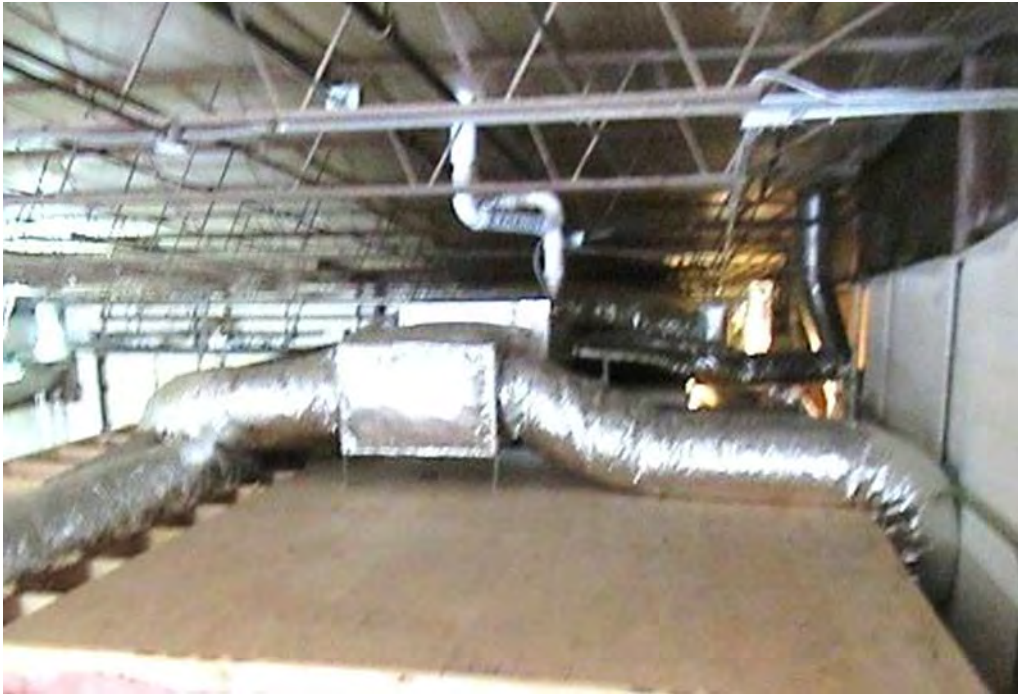
Picture 1

The heating, ventilation and air conditioning (HVAC) system consists of an air handling unit (AHU) located in the garage (Picture 1). The unit supplies heated air to occupied spaces via wall or ceiling vents and returns air back to the unit via wall/ceiling vents. The system does not provide AC, therefore window or portable units are utilized to provide cooling during spring/summer months. The AHU was closely examined and did not appear to have the ability to introduce fresh/outside air. The Massachusetts Building Code requires a minimum ventilation rate of 20 cubic feet per minute (cfm) per occupant of fresh outside air or have openable windows in each room (SBBRS, 1997; BOCA, 1993).

Air handling unit (AHU)

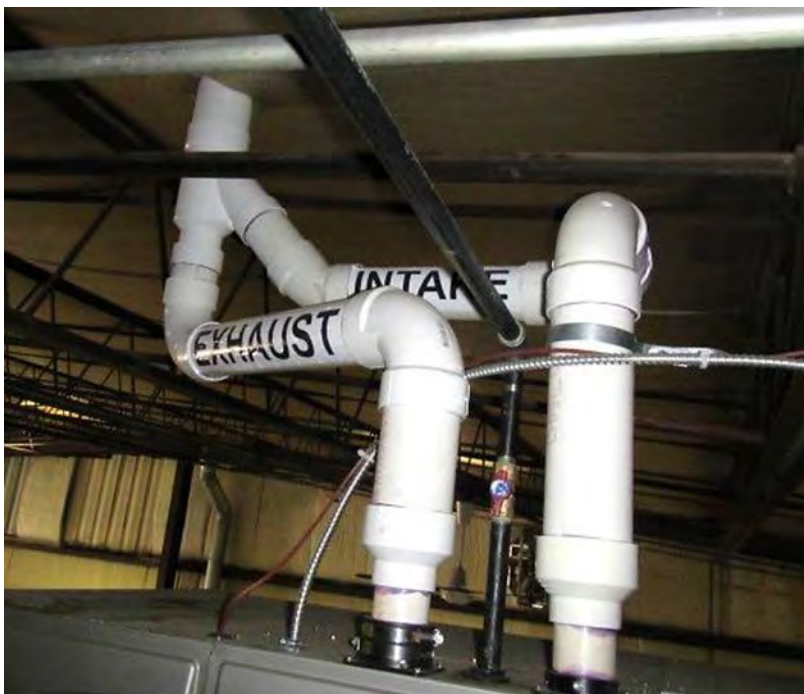
Picture 2

Of significance to IAQ was the configuration of combustion air for the AHU. In order to facilitate proper combustion, a source of oxygen is needed. It appears that the oxygen source for the AHU is connected into a “Y” joint that is shared with the exhaust vent (Picture 2). In this configuration, it is possible that products of combustion from the exhaust vent can be readily drawn back into the AHU. Because there is no mechanical source of fresh air in the building, this situation may be contributing to degraded IAQ. The design/installation of the AHU should be evaluated by an HVAC engineering firm for proper operation.

Oxygen source for the AHU is connected into a “Y” joint that is shared with the exhaust vent

1. Contact HVAC engineer to evaluate configuration of "Intake/Exhaust" pipes of AHU (Picture 2). Make repairs/adjustments as needed.
2. Provide fresh air to the space to comply with building code. This can be done in two ways; install openable windows and/or retrofit HVAC system with a fresh air intake vent.
3. Upgrade filters in AHU to MERV 8 or higher and change a minimum of twice per year (e.g., between heating/cooling seasons) or as per the manufacturer's instructions.
4. Examine restroom exhaust vents for proper operation, increase capabilities as needed.
5. Make repairs to the louvered fresh air supply vent for the local exhaust system in the garage/work area.
6. Consider adopting a balancing schedule of every 5 years for all mechanical ventilation systems, as recommended by ventilation industrial standards (SMACNA, 1994).

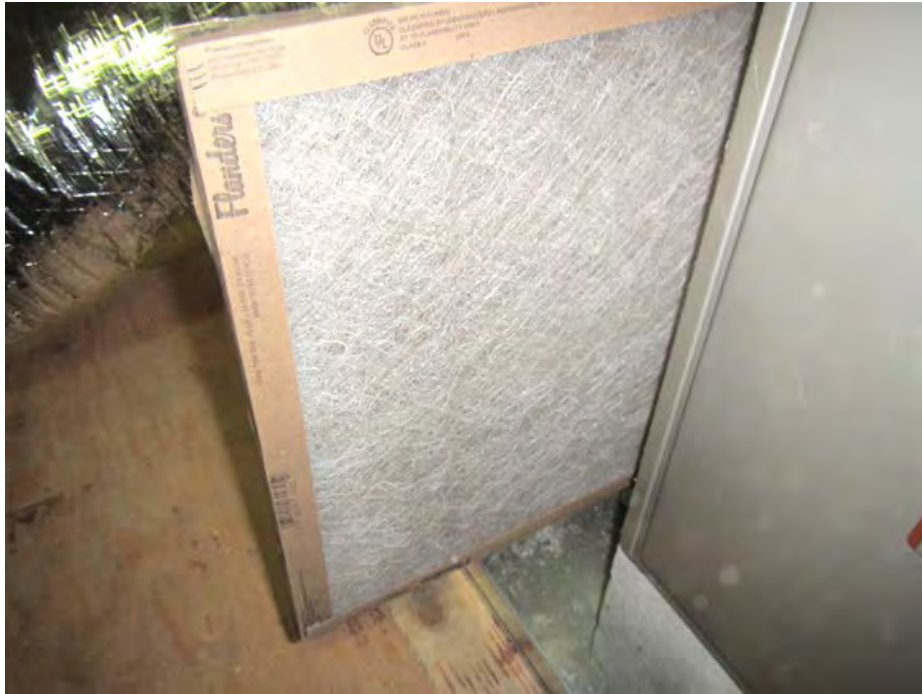
Picture 3

The filters in the AHU were examined. The mesh-style filter (Picture 3) has minimal efficiency to remove airborne particulates and is not recommended. The MDPH recommends pleated filters with a Minimum Efficiency Reporting Value (MERV) of 8, which are adequate in filtering out pollen and mold spores (ASHRAE, 2012). Note, however, that an increase in filtration can cause stress on equipment, which needs to be evaluated to determine if the higher-rated filters will allow adequate function. Filters should also be changed two to four times a year, or as the manufacture’s recommendations.

Mesh AHU filter

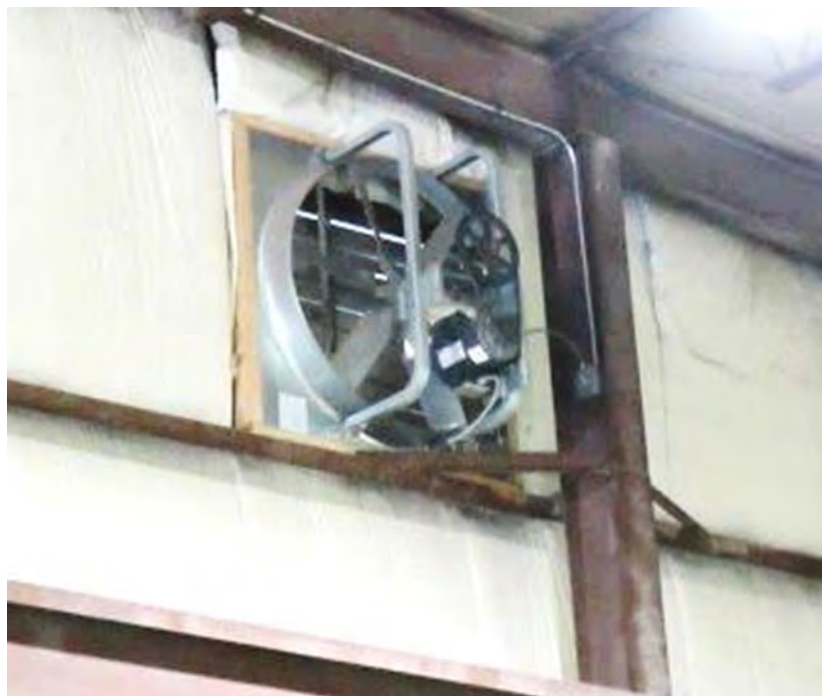
Picture 4

The building is equipped with a garage/work area where vehicles can be driven in and the door closed. The garage is outfitted with a local exhaust system to remove vehicle exhaust/airborne pollutants, which consist of a large exhaust fan (Picture 4) and a louvered

Local exhaust vent for garage/work area

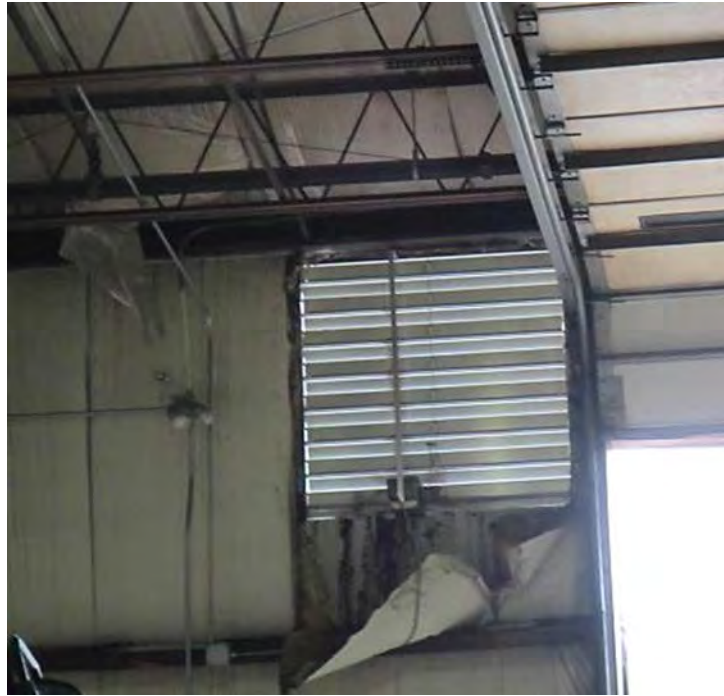
Picture 5

supply vent (Picture 5) to provide make-up air. It was reported that the supply make-up louvers were inoperable at the time of assessment.

Louvered make-up/supply vent

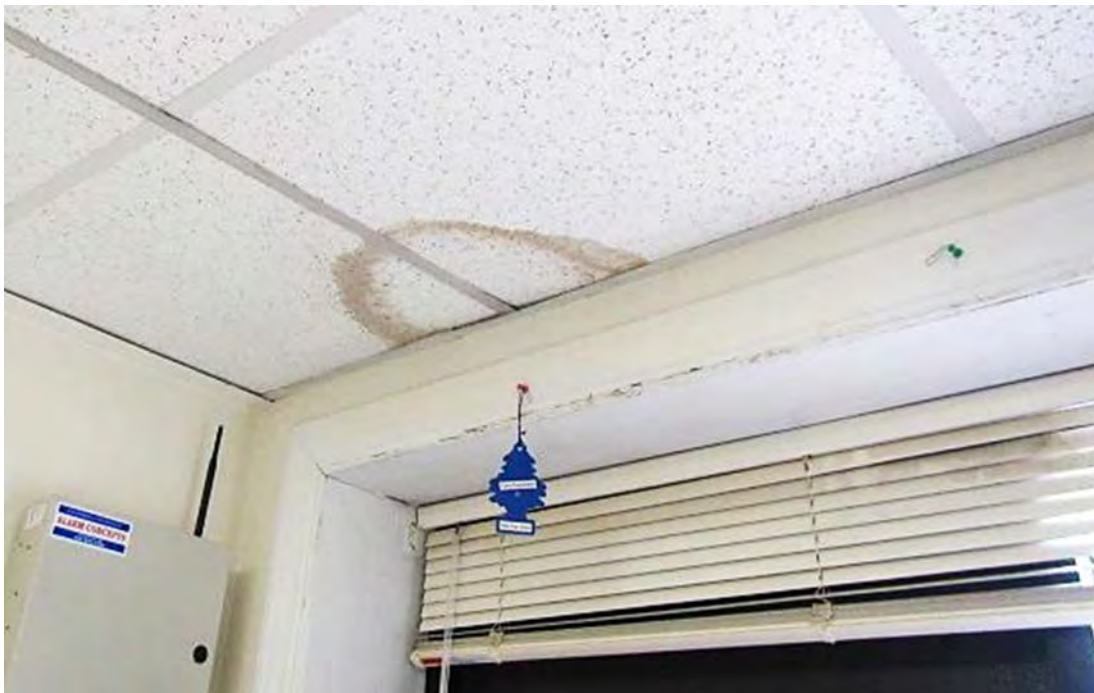
Picture 6

A number of areas in the building had water-damaged ceiling tiles (Table 1, Pictures 6 through 8). Stained or damaged ceiling tiles indicate roof or plumbing leaks. Tiles should be replaced once leaks are found and repaired.

Water-damaged ceiling tiles

8. Replace water-damaged ceiling tiles after leaks are discovered and repaired.
9. Clean mold growth from refrigerator and gaskets in garage/work area. If they cannot be adequately cleaned, consider replacing gaskets. Consider relocating refrigerator inside office space (not garage).

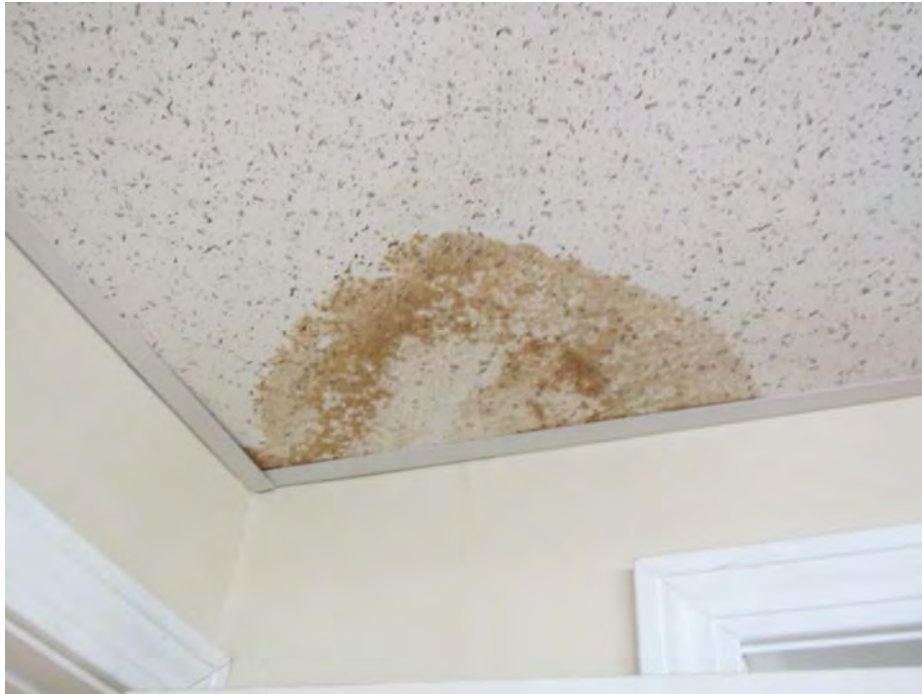
Picture 7

Water-damaged ceiling tile

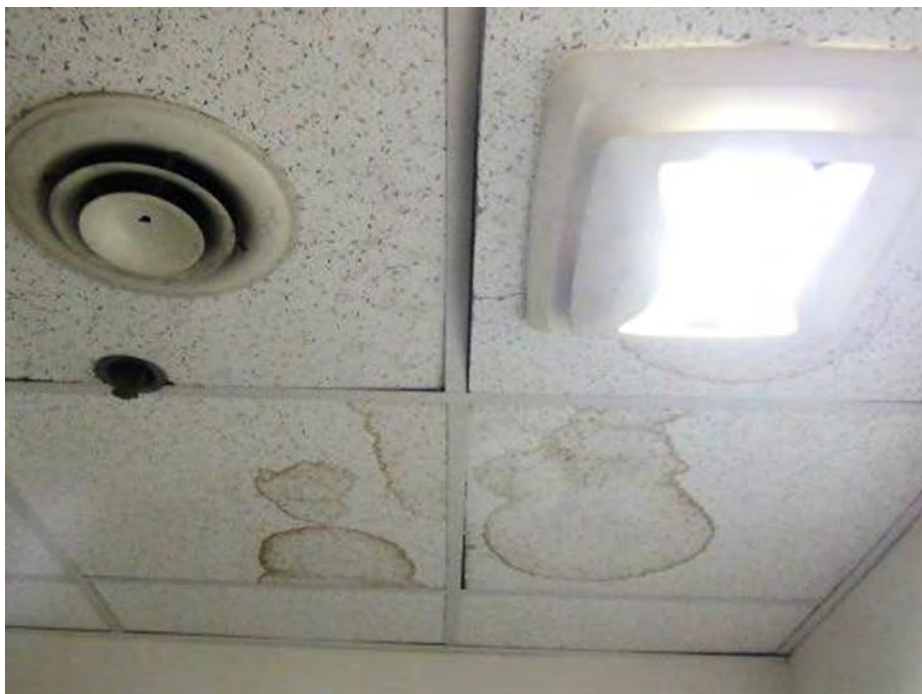
Picture 8

Water-damaged ceiling tiles

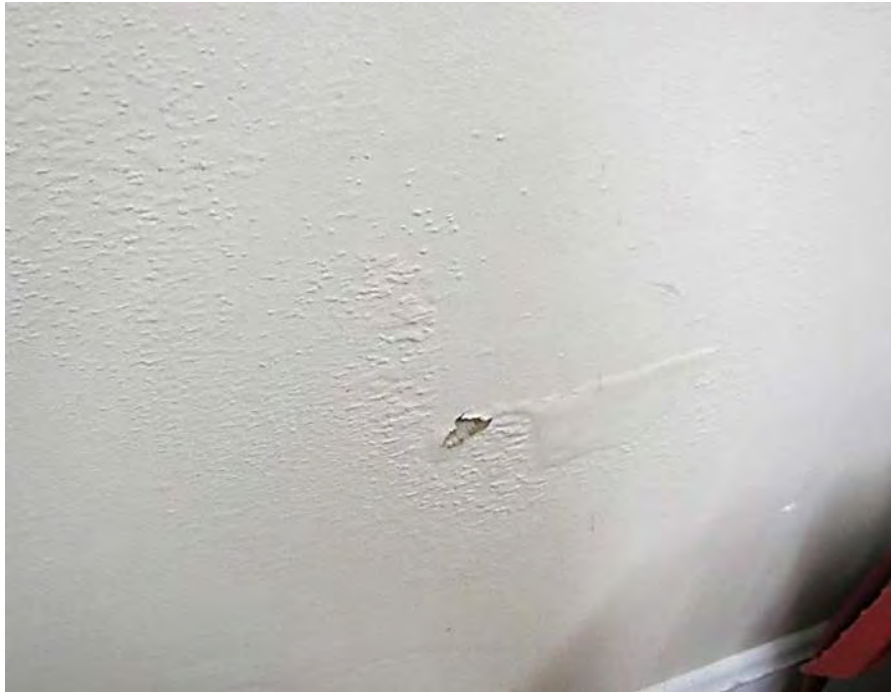
Picture 9

Bubbling paint was noted on the gypsum wallboard of the Water Department Break/Meeting Room (Picture 9). Moisture testing results indicated that the material was slightly moist. No visible mold was observed. This area should be scraped, repainted and closely monitored for further moisture exposure.

Bubbling paint on wall of the Water Department Break/Meeting Room

10. Determine/mitigate source of moisture in Water Department Break/Meeting Room. Scrape, repaint bubbled wall and monitor for further water damage and/or mold growth. Remove/replace if necessary.

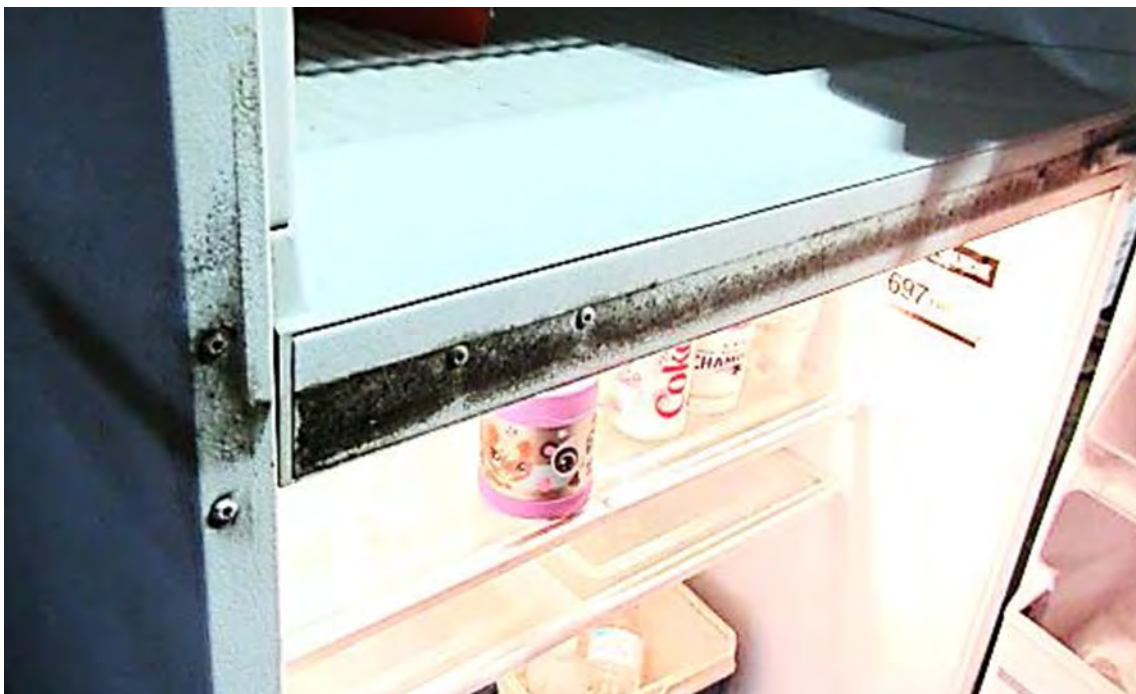
Picture 10

Visible mold growth was observed in and on the refrigerator in the garage. Visible mold growth/staining was seen on the exterior of the refrigerator (Picture 10) and on gaskets (Picture 11). The mold growth is most likely due to condensation from exposure to temperature extremes in the non-conditioned garage, particularly since garage doors are left open most of the time.

Visible mold growth (dark staining) on refrigerator in garage

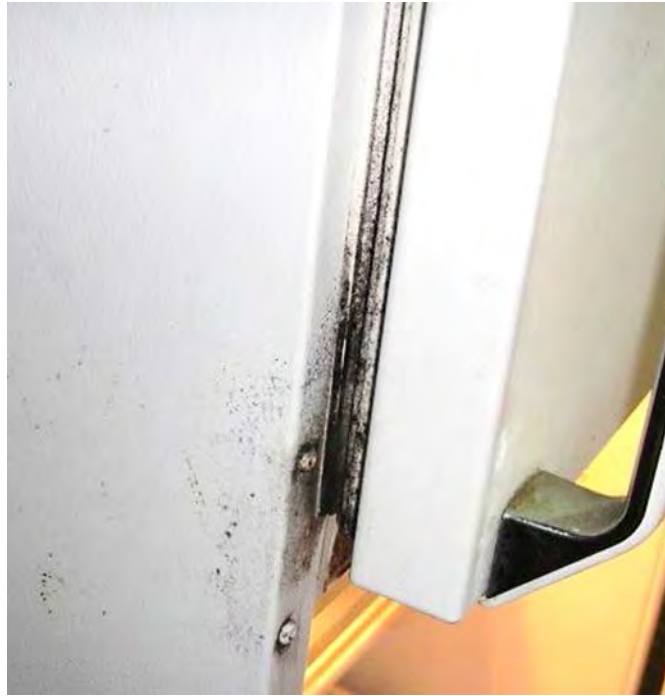
Picture 11

Visible mold growth (dark staining) on refrigerator in garage

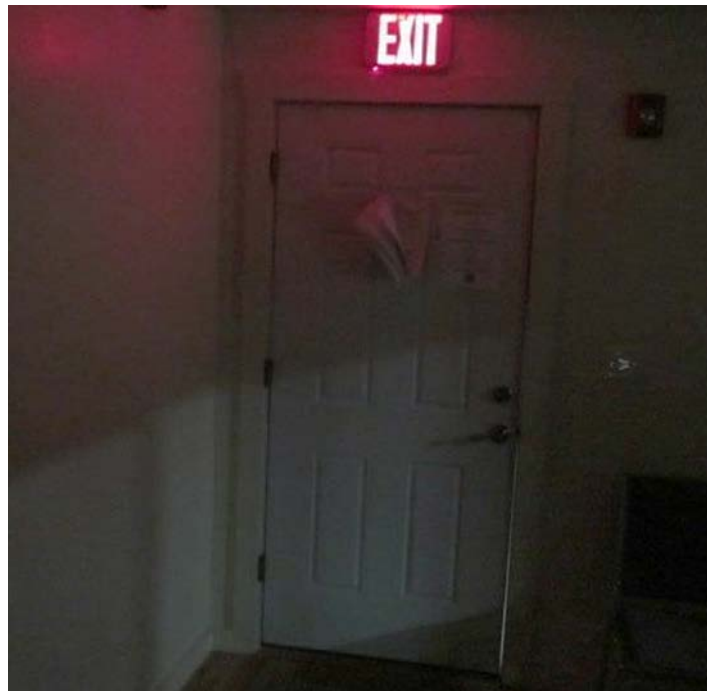
Picture 12

Spaces were observed around doors to office space that lead into the garage (Picture 12). These breaches can serve as pathways for garage pollutants to enter occupied areas, particularly if the local exhaust system is not operating.

Light penetrating around door leading to garage

15. Replace old worn carpeting past its useful life (> 10-11 years).
16. Tighten seals around doors leading off the garage/work area. Repair/replace weather-stripping on/around doors, as well as any other areas in the building where light or drafts can be seen/detected.

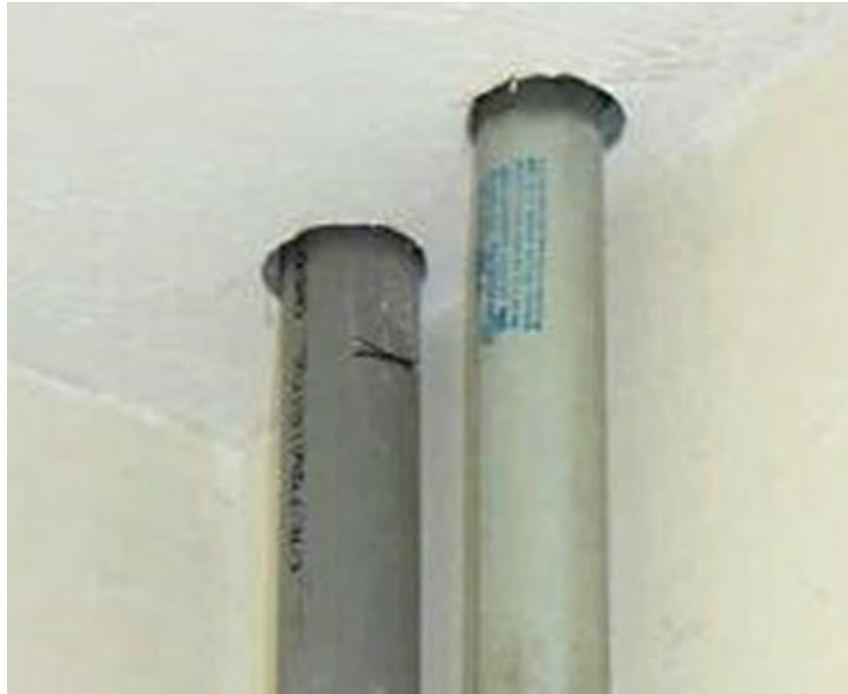
Picture 13

Open utility holes were observed in the Water Superintendent's office (Pictures 13 and 14). These spaces can provide a pathway for odors and particulates from wall cavities into occupied areas.

Open utility holes around pipes in the ceiling of Water Superintendent's office

11. Seal open utility holes (e.g., Picture 13) with a fire-rated sealant.
12. Replace missing ceiling tiles (e.g., first floor restroom Picture 15) to prevent exposure to dust/debris/fiberglass.

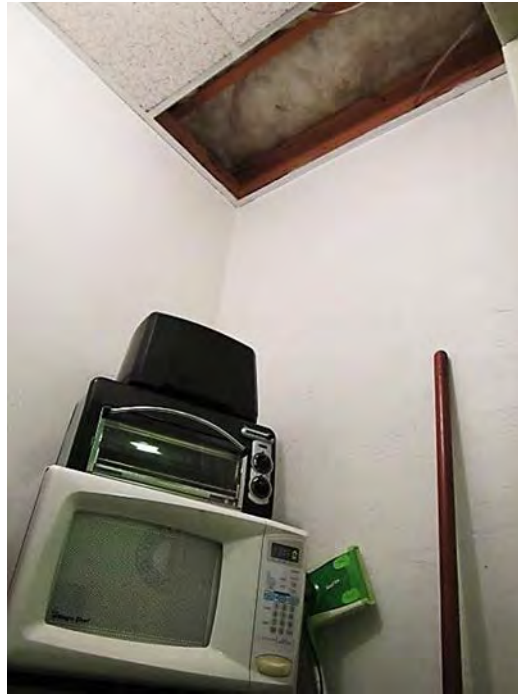
Picture 15

A missing ceiling tile was observed with exposed fiberglass insulation in the first floor restroom, which is also located above a food station (Picture 15). Missing ceiling tiles can create pathways for dust/debris in the ceiling plenum into occupied areas. Fiberglass insulation can provide a source of eye, skin and respiratory irritation.

Missing ceiling tile/exposed fiberglass insulation above food station

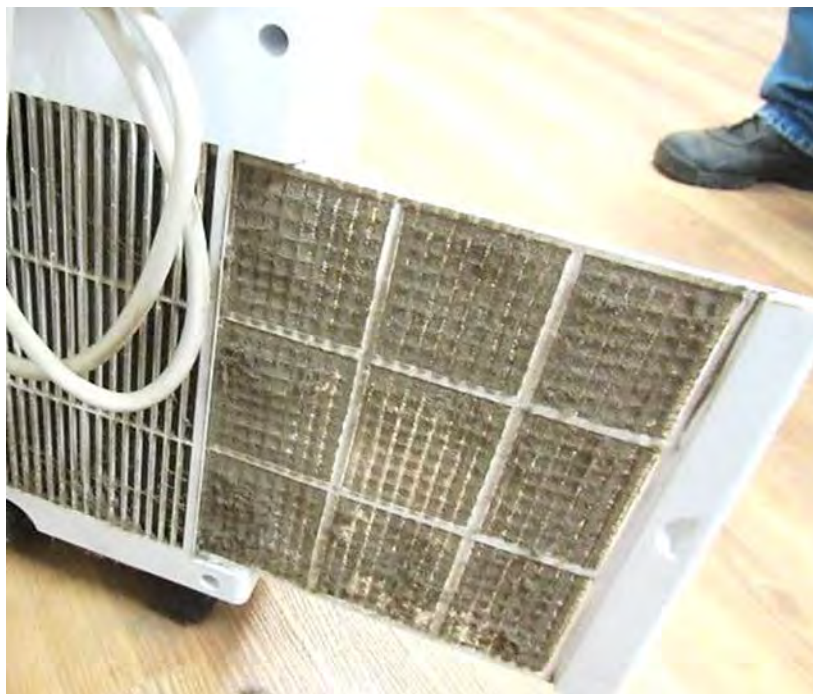
Picture 16

Finally, portable and window-mounted ACs are equipped with filters. The filters examined were occluded with dust/debris (Table 1, Picture 16) and should be cleaned as per the manufactures' recommendations or more frequently if needed.

AC filter for portable unit in Water Department Break/Meeting Room

17. Clean AC filters prior to the cooling season and as needed.
18. Ensure ACs are draining properly either outdoors or into proper receptacle.
19. Refer to resource manual and other related indoor air quality documents located on the MDPH's website for further building-wide evaluations and advice on maintaining public buildings. These documents are available at <http://mass.gov/dph/iaq>.
